Report on the Investigation of a Marine Accident.

Foundering of a Latvian f/v *GIDEON* in the Atlantic Ocean, May 25th 2005.

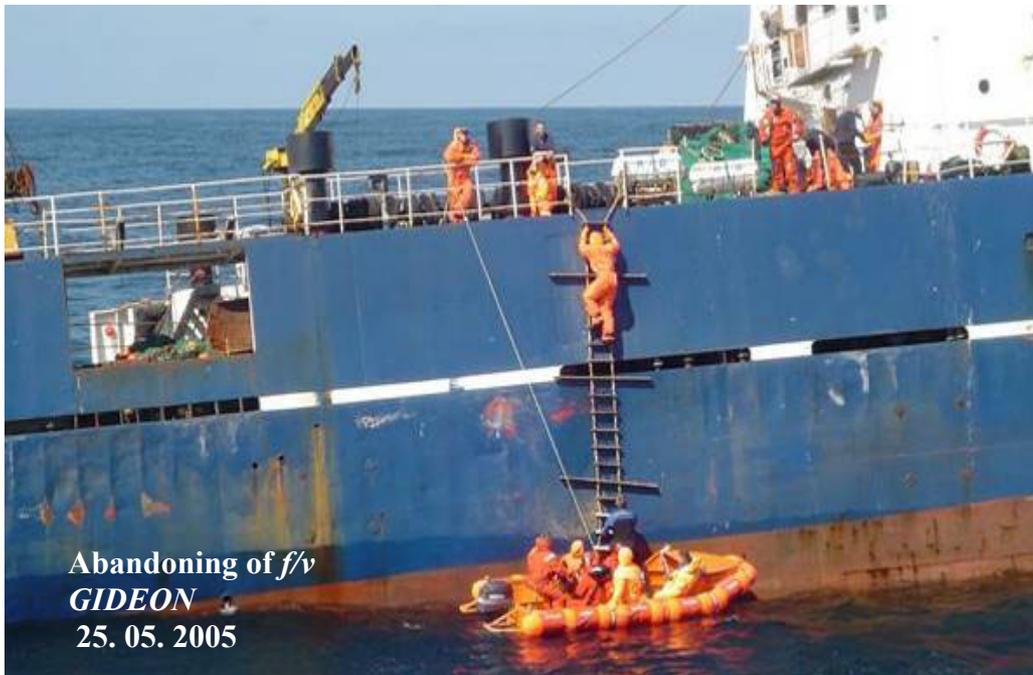
- 14.12. At 17:50 the Icelandic *Fish Captain* saw the water being already on the deck of the FFD;
 - 14.13. At 18:00 the last crewmembers – the Latvian *Master* and the Icelandic *Fish Captain* – abandoned the ship. It had taken the motor boat of the *f/v PETUR JONSSON* to travel to and from the *f/v GIDEON* three times to evacuate all the 15 crewmembers;

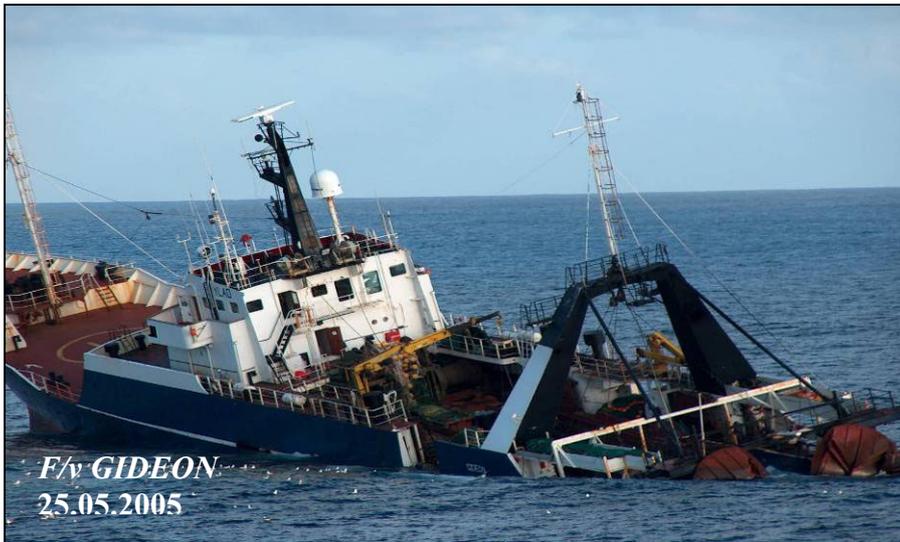
Ships port side after the fire

- 16.1.1. There are photographs at the disposal of the investigation taken from board the *f/v PETUR JONSSON* and other ships showing the *f/v GIDEON* before sinking and in the process of sinking. Neither of these photographs show anything that could be considered a trace left by fire;

- 16.1.2. No sign of "fire" can be traced on the white painting of the ship's deck constructions (the masts, superstructure etc.) bears, as the white painting is neither blackened with soot nor burnt;
- 16.1.3. Near the *f/v GIDEON* no smoke can be noticed in the atmosphere (it is sunny, no wind blowing);
- 16.1.4. When comparing the photographs of the *f/v GIDEON* to a photograph where a fire on board a similar *f/v SOZIDANIE* has been pictured (sunny weather, no wind blowing), then clearly visible traces of a fire on the masts of the ship can be noticed. **Not even a slightest trace of a fire can be noticed when examining the photographs of the *f/v GIDEON*.**

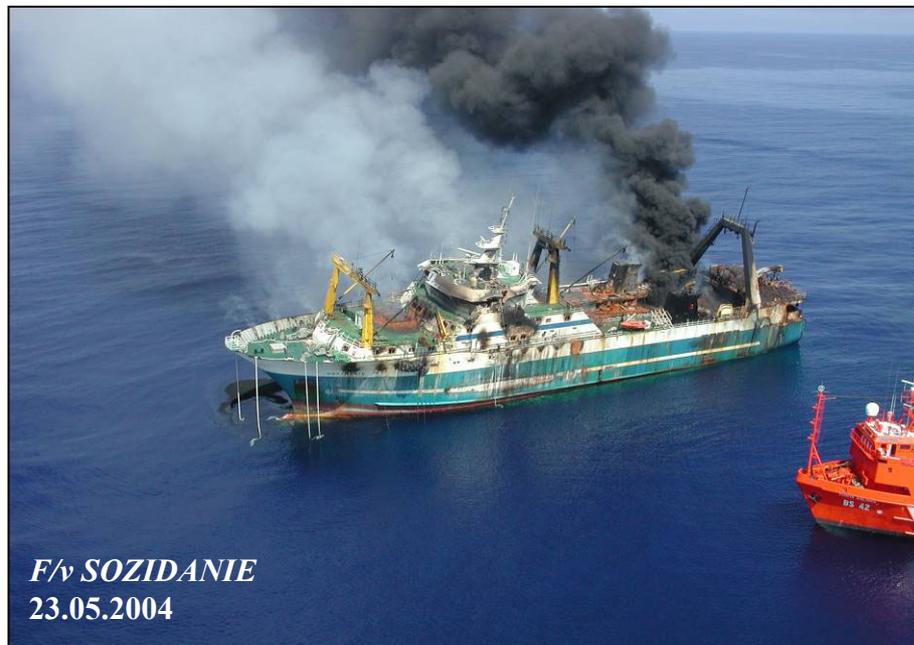
Fire on board the *f/v SOZIDANIE*

- 16.1.5. The testimonies of the smoke divers considered to be true (thick black smoke due to which one hour after flooding of the CO₂ extinguisher the visibility in the ship's ER had been 1-2 m) they would suggest a large-scale fire having happened in the ship's ER, consequently after the fire had been extinguished there would have been smoke coming from the ship's ER for several hours which could be seen on the photographs. Traces of fire - the blackened with soot painting and, possibly, also burns – should have been noticeable on the white painting of the surfaces of the ship's superstructure and/or deck constructions;

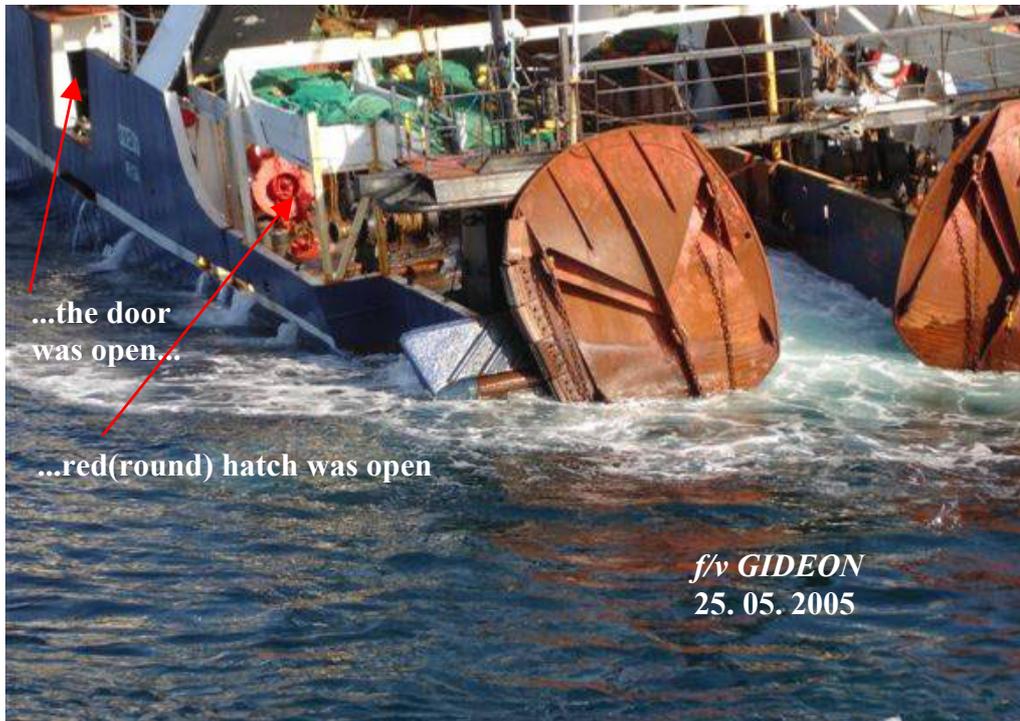
Information supplied by IMAB

Engineer, who had worked on board this ship only for 3 weeks noted in his report that during the voyage there had been a problem with the shaft generator, which at times used to switch off due to decrease in voltage;
16.2.5. The rapid flooding of the ship's ER confirms the evidence given by the Master of the *f/v PETUR JONSSON* as to the ship's hatches and doors not having been closed;
