Report on the Investigation of a Marine Accident.

Foundering of a Latvian f/v *GIDEON* in the Atlantic Ocean, May 25th 2005.

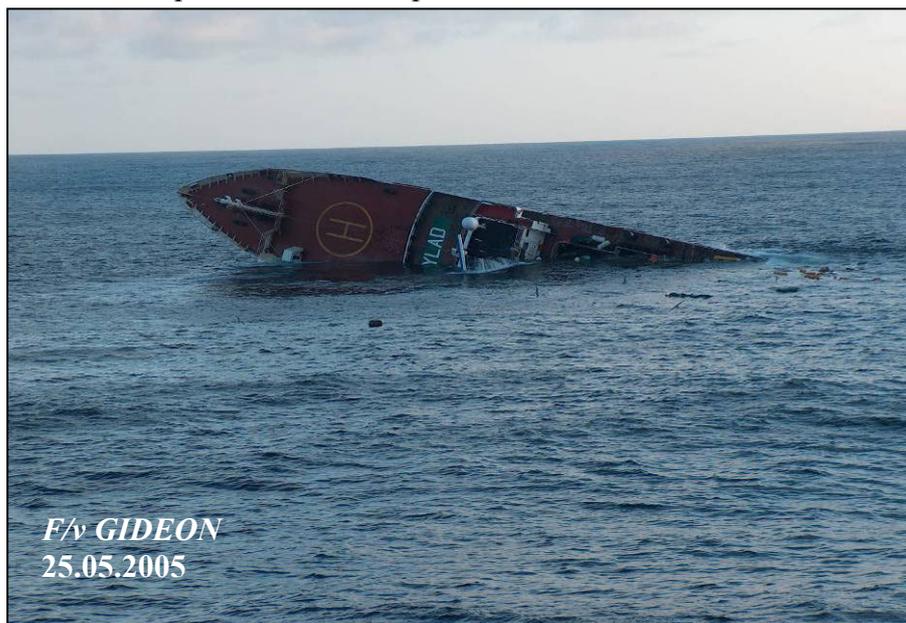
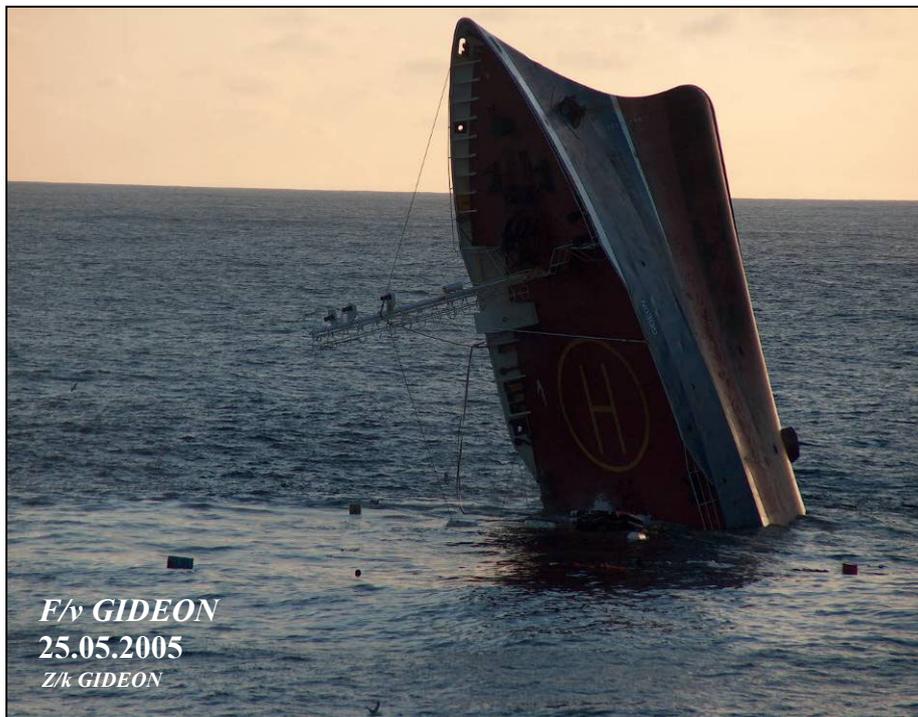
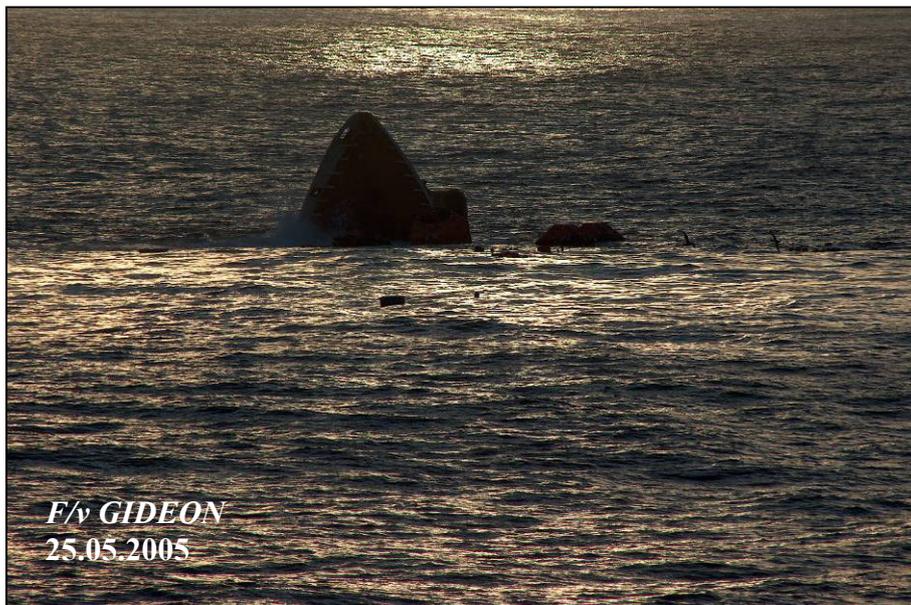
After the "fire" and flooding of the ship's ER the f/v *GIDEON* foundered at about 22:00 UTC on May 25th 2005. in position of $\varphi=47^{\circ}52,7'N$, $\lambda=045^{\circ}18,5'W$ to the depth of about 300 m. All 15 crew members of the f/v *GIDEON* were evacuated from board the ship and taken to the port of St.Jones.

- 16.1.2. No sign of "fire" can be traced on the white painting of the ship's deck constructions (the masts, superstructure etc.) bears, as the white painting is neither blackened with soot nor burnt;
- 16.1.3. Near the *f/v GIDEON* no smoke can be noticed in the atmosphere (it is sunny, no wind blowing);
- 16.1.4. When comparing the photographs of the *f/v GIDEON* to a photograph where a fire on board a similar *f/v SOZIDANIE* has been pictured (sunny weather, no wind blowing), then clearly visible traces of a fire on the masts of the ship can be noticed. **Not even a slightest trace of a fire can be noticed when examining the photographs of the *f/v GIDEON*.**

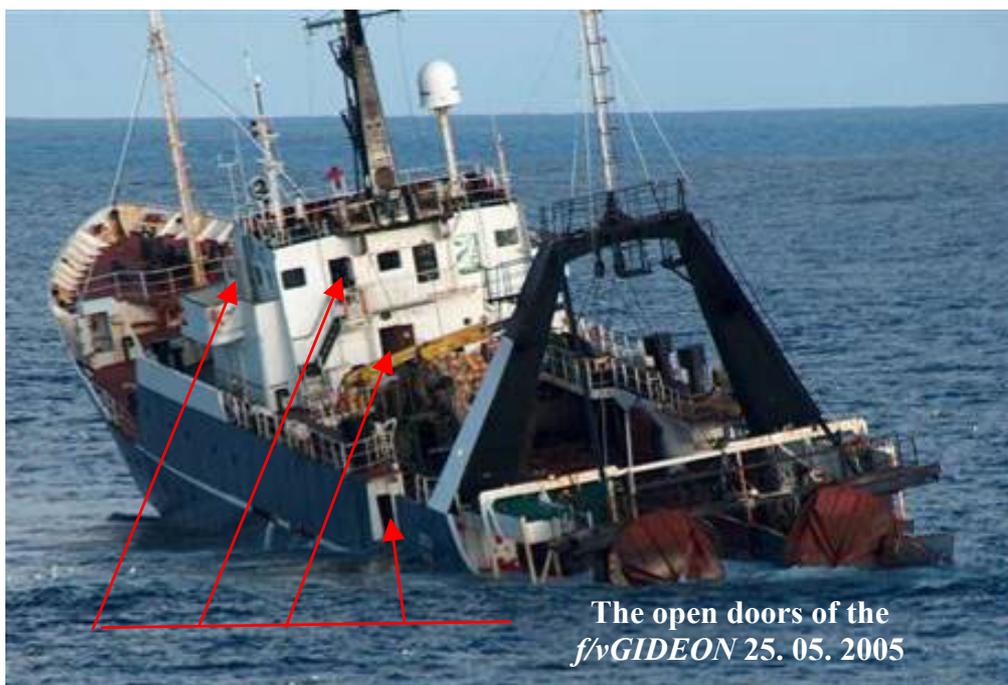
Information supplied by IMAB

16.2.6. Due to the fact that the investigation did not manage to obtain a single evidence that would logically explain the reasons for the flooding of the ship's ER, deliberately evil actions of the crewmembers as the reason for foundering of the vessel cannot be excluded.
